Special Report 83-15

May 1983

Cold Regions Research &
Engineering Laboratory

Shoreline erosion and shore structure damage on the St. Marys River 1980 closed navigation season

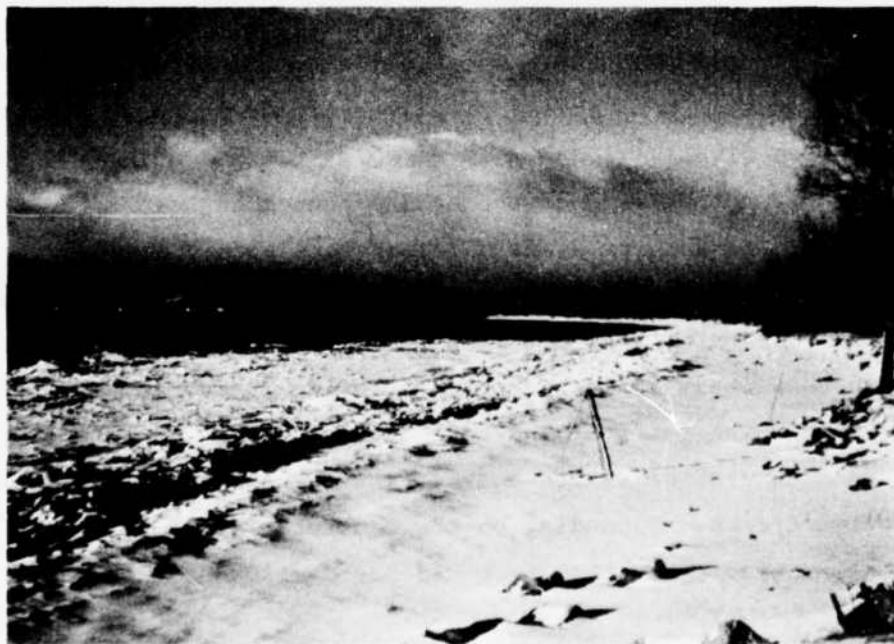
The role of ice in sediment transport and shoreline erosion has many facets. The most obvious effect is that ice formed on a shore or riverbank may isolate and thereby protect the shore as shown in Figure 1. Ice formations can, however, cause significant localized damage by gouging ordinarily stable beach or bank formations and removing protective vegetation, by adfreezing sediment at the ice/soil interface, and by entraining sediment within the ice structure.

Figure 1. Early winter shore ice.

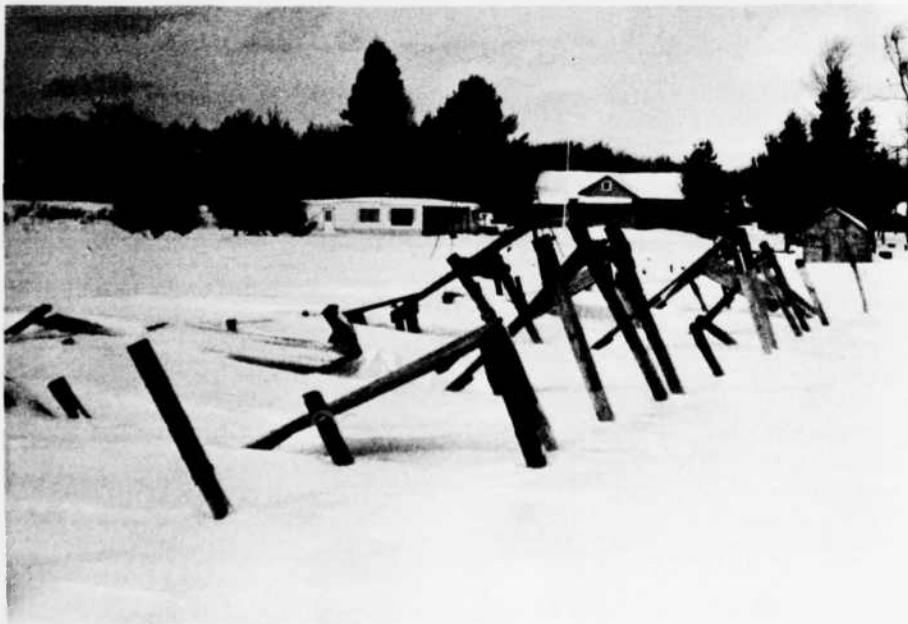
Figure 3. Series of finger piers damaged by ice jacking.

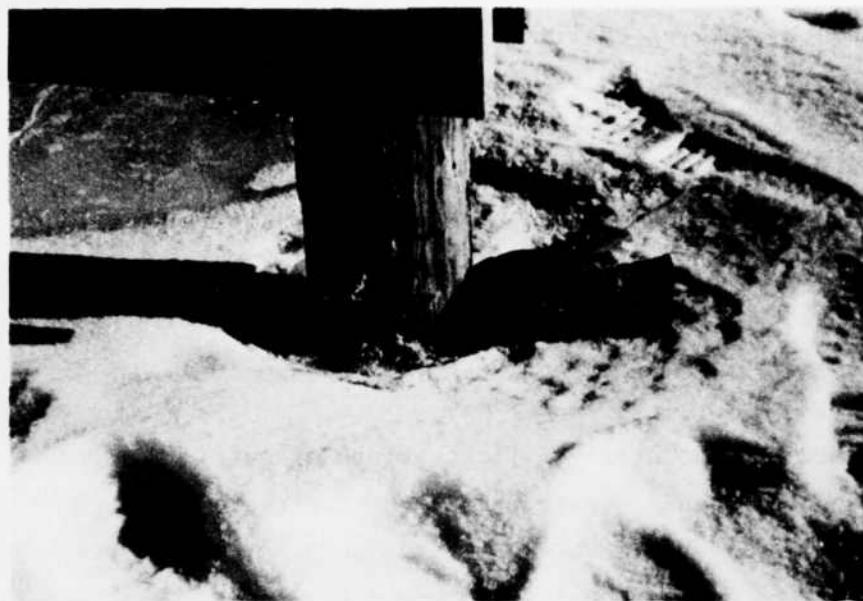
Figure 4. Abrasion of wooden pile by ice motion. Note the wood shavings.

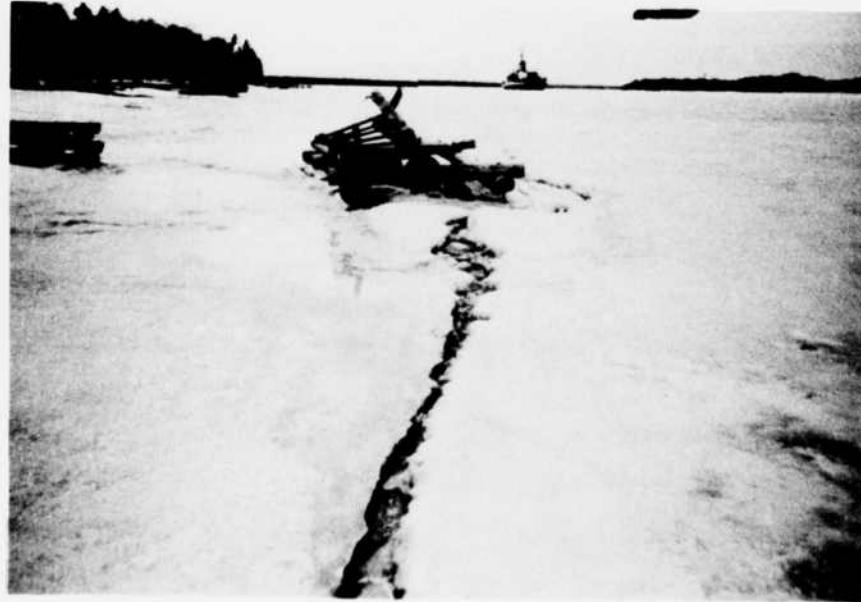
Figure 5. Active crack passing through dock.

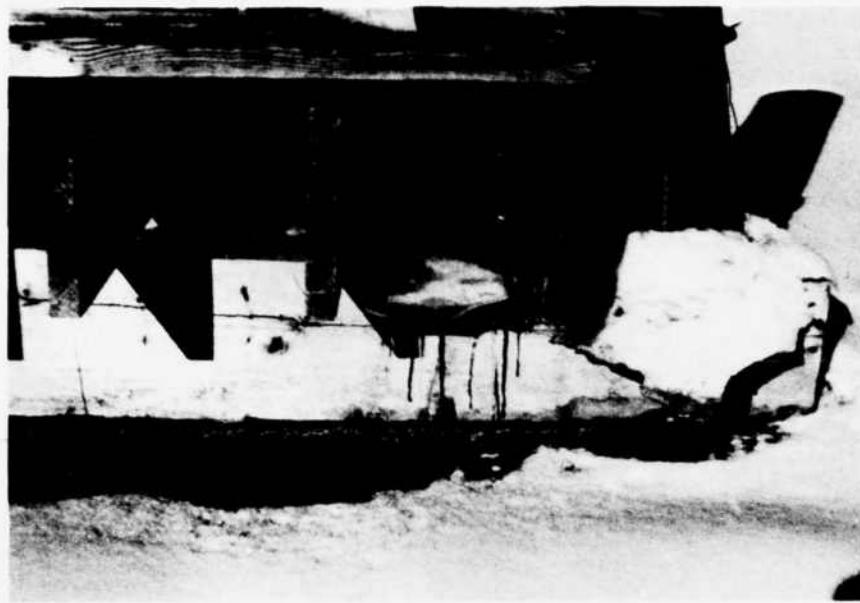
Figure 6. Horizontal member of dock in contact with ice cover.

horizontal members of a dock. Docks can also be damaged if the water level is high enough so that the ice surface touches the cross members; then the ice forces act directly on the structure (Fig. 6).

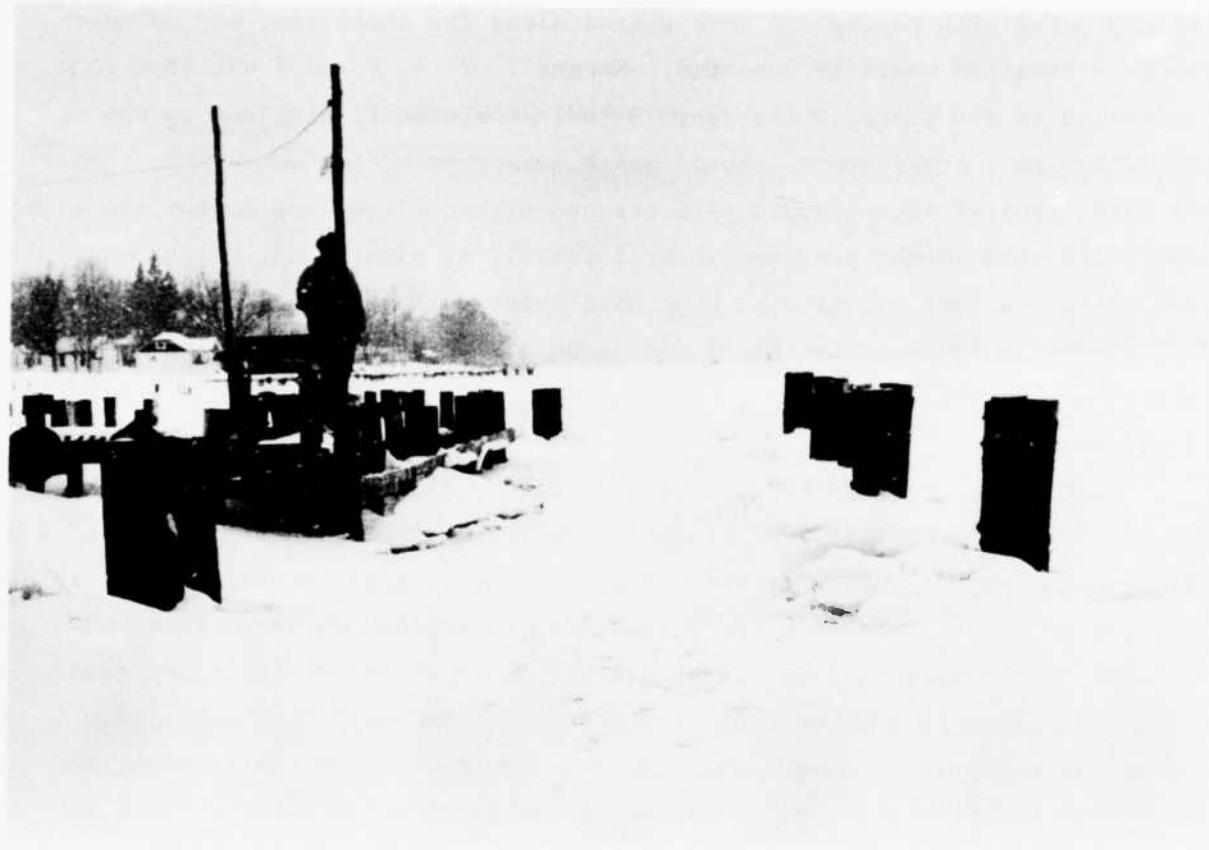
Six Mile Point. Six Mile Point is an area of significant damage potential due to navigation, but the structures are constructed better than most along the St. Marys River. The docks at LaPeers Marine Gulf Station consist of a main dock perpendicular to the shoreline, with eight finger piers extending from it parallel to the shore. This structure is surrounded by 12 pile clusters (Fig. 8).

Figure 8. Dock at Six Mile Point.

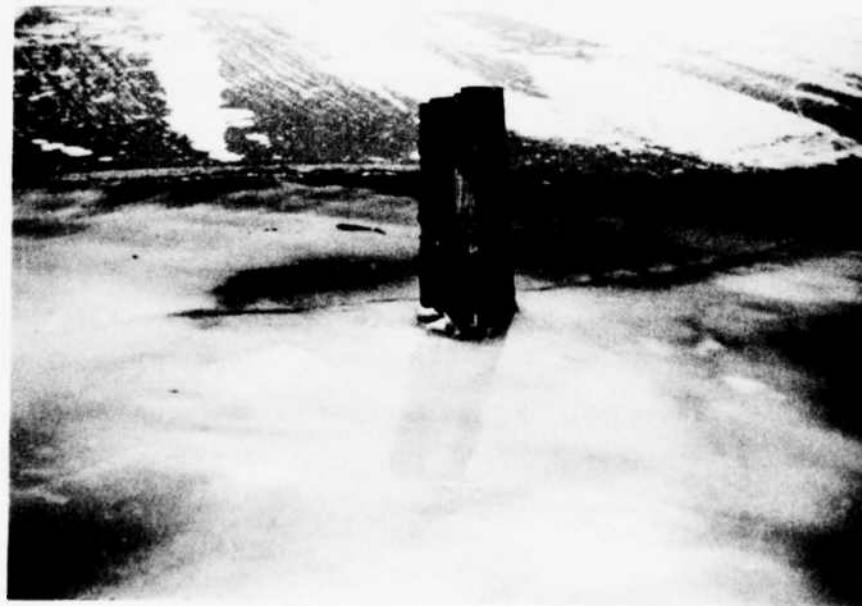
Figures 9 and 10 were taken on 11 January 1980 just after navigation ceased. Figure 9 shows the active crack that can develop between the pile clusters at this site; the crack isolates the docks from vertical forces due to water-level fluctuations (including ship-induced fluctuations). Figure 10 shows some ice rubble due to horizontal movement of a thin, early ice sheet. Thus, pile clusters can help to protect a dock against both horizontal and vertical movements of the ice sheet. A change in water levels will still influence the ice about the dock (Fig. 11), but the effective area of the ice that develops the vertical force on the dock is smaller and the group action reduces the uplift force on any single pile.

Figure 9. Active crack at pile cluster.

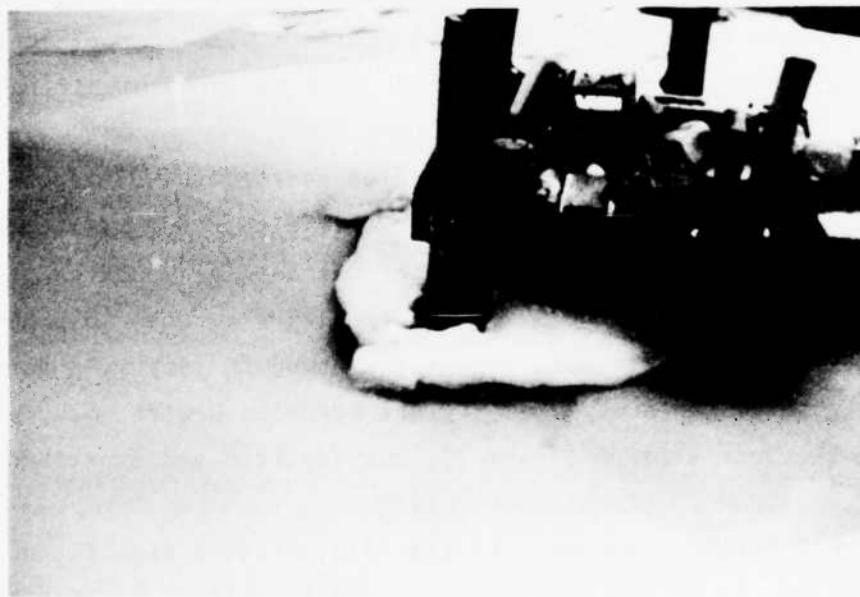
Figure 11. Ice collar on small dock piles.

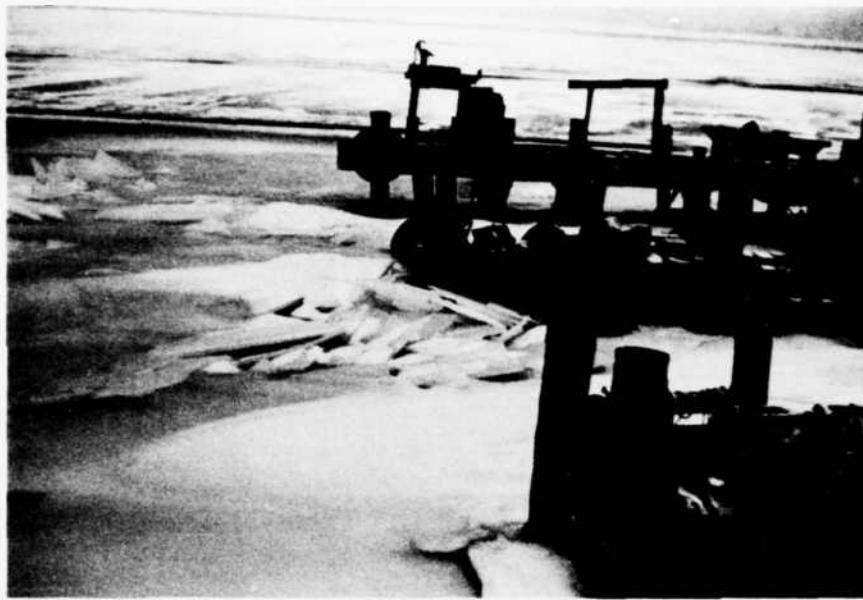
Figure 12. Horizontal movement of ice against dock.

Thin ice or small floes may still move horizontally against a dock (Fig. 12), but due to their limited size, forces are reduced. The docks at Six Mile Point were monitored throughout the closed navigation season, and although modes of ice action similar to those during periods with navigation were evident, no perceptible damage was observed.

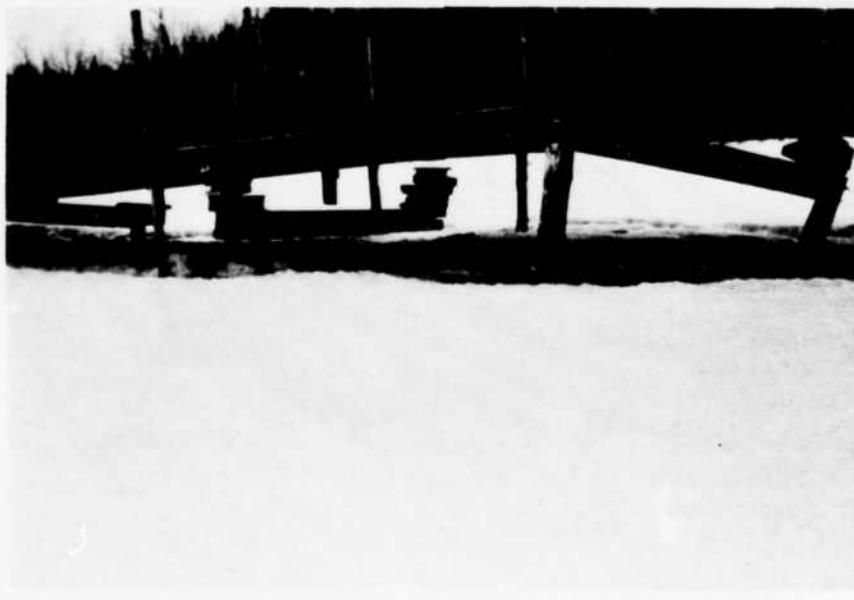
Dark Hole, Neebish Island. Another site monitored during the closed navigation season was the area known as the Dark Hole on Neebish Island. During previous years the Franklin Resort dock suffered significant damage due to uplifting forces (Figs. 13 and 14).

Figure 13. Franklin Resort Dock, end view (1976-77 winter).

Figure 14. Franklin Resort Dock, side view (1976-77 winter).

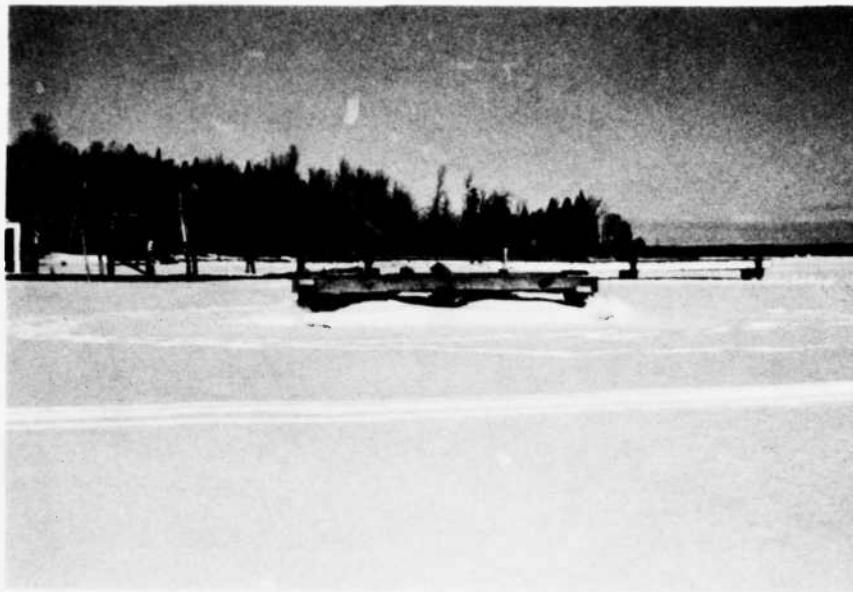
Prior to the 1978-79 winter navigation season, the Corps of Engineers had two demonstration docks installed at this site. One was a rock-filled timber crib (Figs. 15 and 16). The other was a pile-supported structure, with pile surfaces of various materials ranging from wood to plastic to steel (Fig. 17). Both of these structures stood up very well during both winters they were in place. The original Franklin Resort dock, which can be seen on the left side of Figure 15, was repaired and experienced no perceptible damage during the winter of 1980.

Figure 15. Dark Hole timber crib.

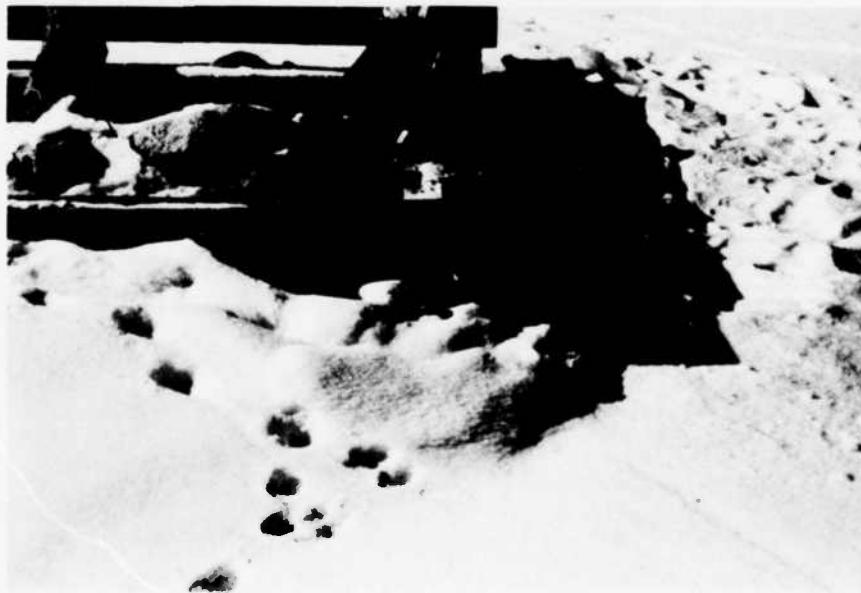
Figure 16. Timber crib close-up.

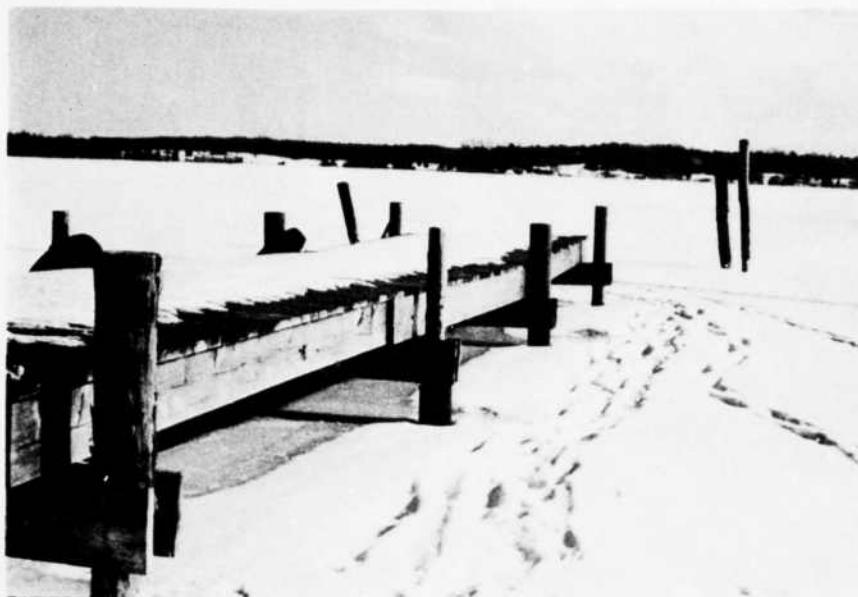
Figure 17. Dark Hole pile dock.

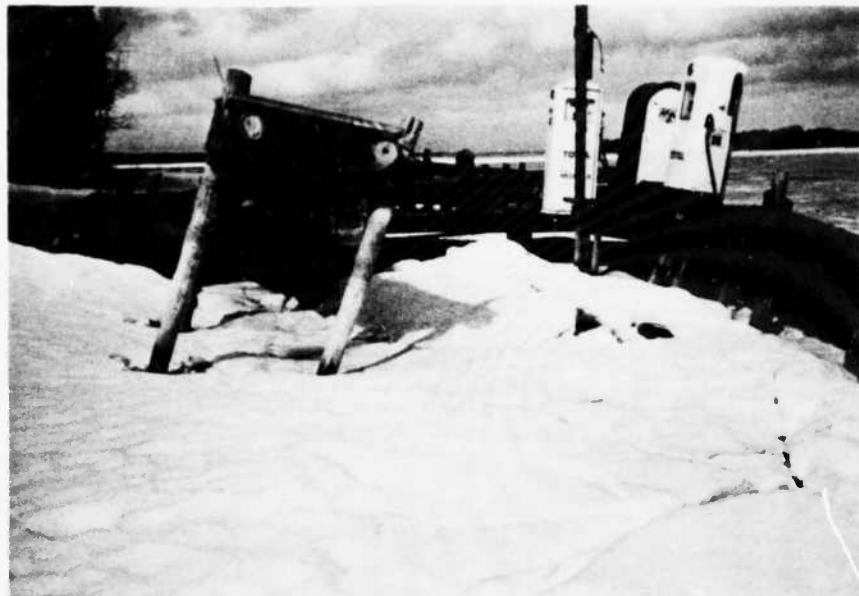
Figure 19. Spreading of finger piers by ice action.

view of the area during the 1977 navigation season and shows a large shore-parallel active crack passing just offshore of the structure. Other cracks passed through the structure that year, spreading the finger piers (Figs. 18 and 19).

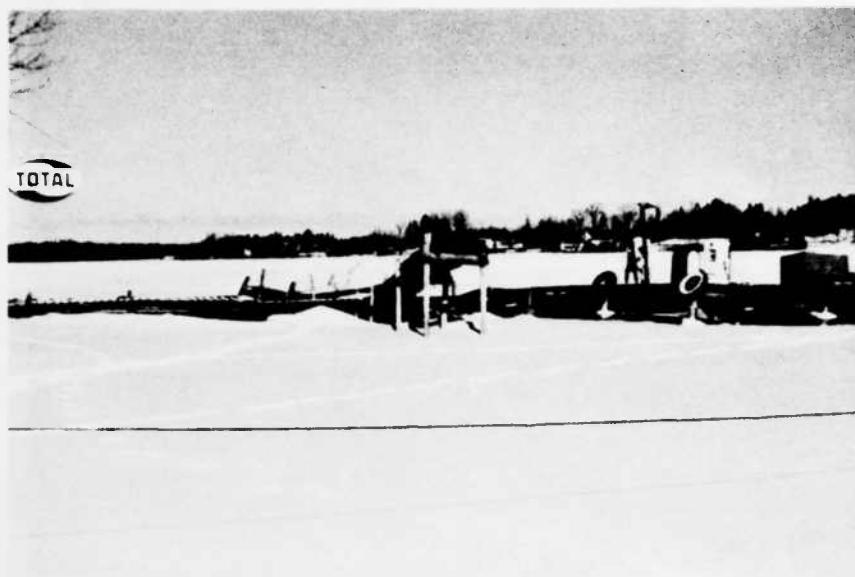
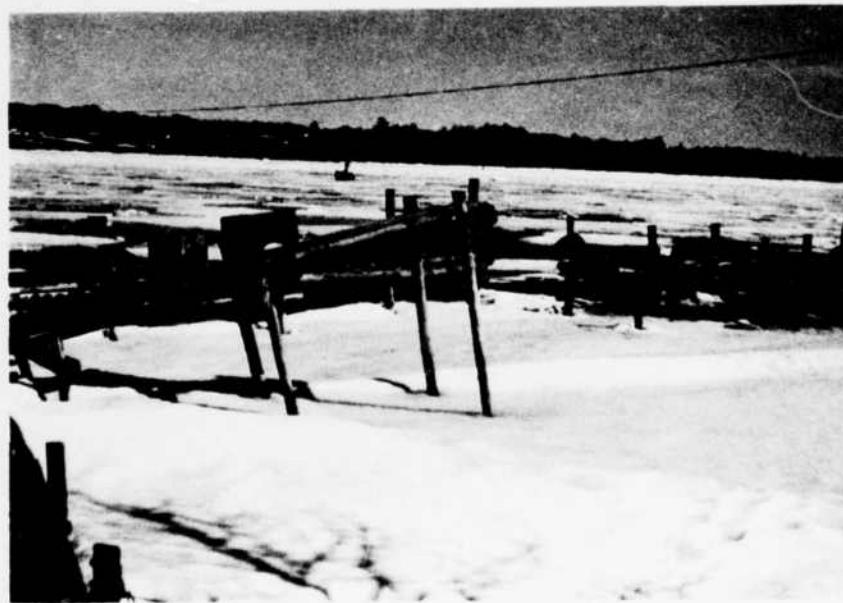
During the 1980 closed navigation season these cracks were not evident. Figure 20 shows conditions several weeks after the close of navigation. The dock shown in Figure 20 had been uplifted before the close of navigation and did not change during the closed period (Fig. 21).

Figure 20. Little Neebish Resort at beginning of closed navigation season.

Figure 21. Little Neebish Resort with navigation re-opened.

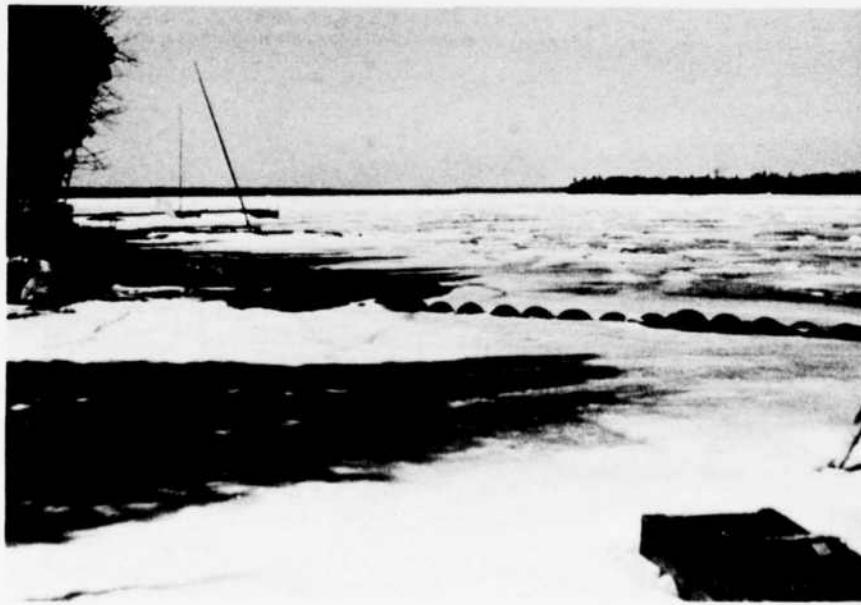
Figure 22 shows the docks at the Little Neebish Resort during spring breakup. The left side of the structure in this picture is another Corps of Engineers structure, which is supported on piles of various composition. It sustained no perceptible damage throughout the winter. The large, floating ice masses were prevented from flowing against the docks by an area of intact shorefast ice upstream (Fig. 23).

Figure 23. Shore-fast ice and tire boom at Little Neebish Resort. The tire boom was another Corps of Engineers project in 1978-79 to control ice.

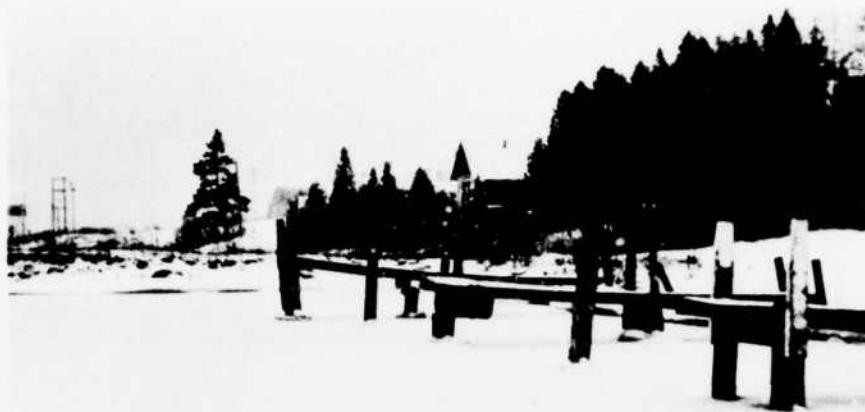
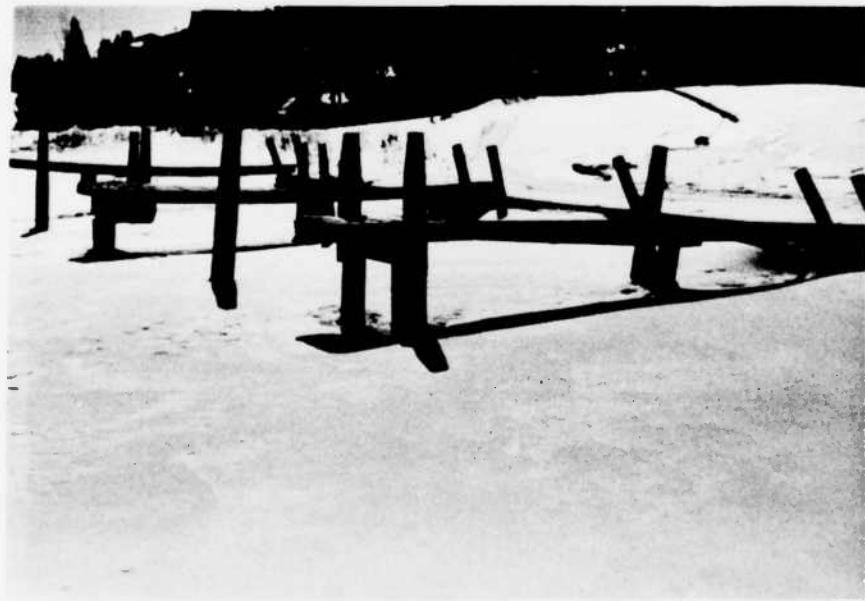
Detour. Figure 24 shows the condition of a series of small docks near the mainland Drummond Island Ferry dock on 25 February 1980. Some uplift is apparent, but as shown in Figure 25 taken on 15 March 1980 near the end of the closed navigation season, no further damage was apparent through the closed navigation period.

Figure 24. Small dock at Detour after close of navigation.

Figure 25. Small dock at Detour near opening of navigation.

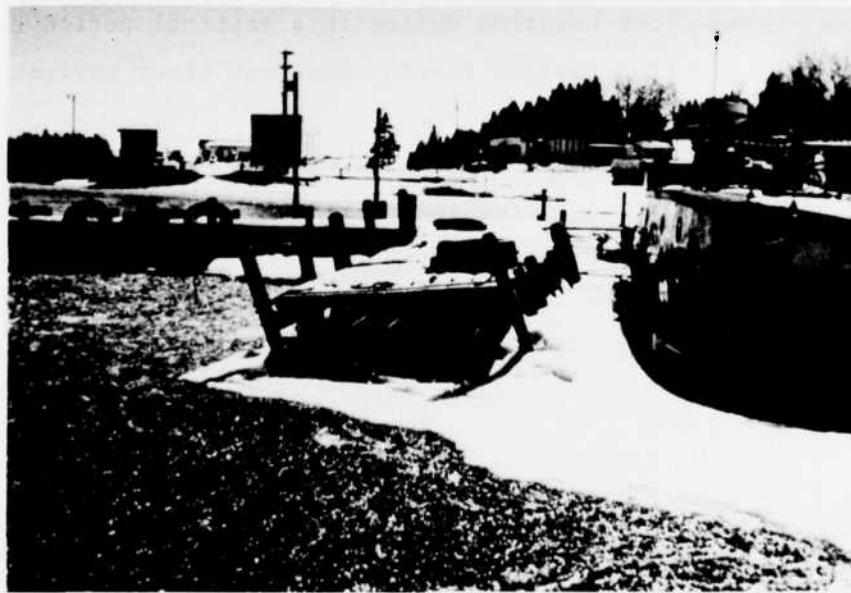
Figure 28. Damaged Lake Carriers dock with fishing boat.

Figure 29. Damaged Lake Carriers dock near opening of navigation.

of the dock. Figure 28 shows another portion of this same facility on 25 January 1980; this part had sustained some damage due to horizontal forces (possibly ice) prior to the closed navigation season. Figure 29 shows the same structure on 15 March 1980 near ice out with no further apparent damage.
